DYNAMIC ANALYSIS GROUP LLC

BOCOUM (OUMAROU) V. DTNA-TRW

January 31, 2020

Nicholas J. Durisek, Ph.D., P.E.

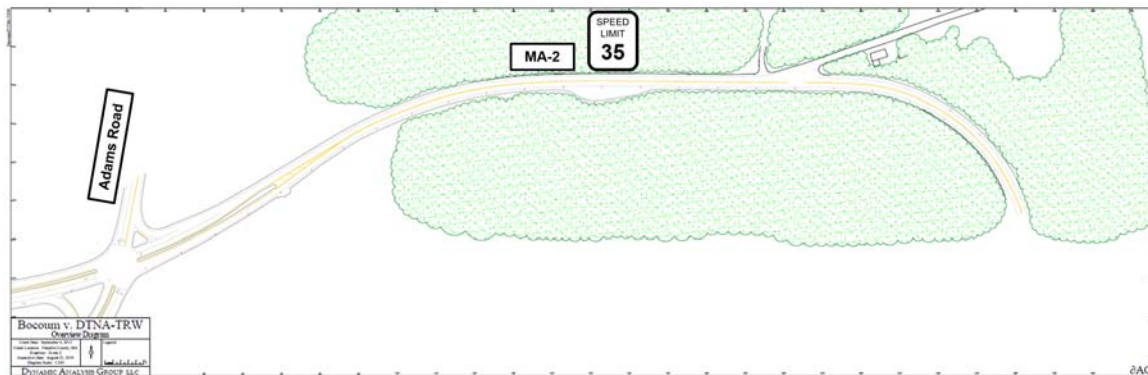
Figure 3. Overview diagram of the scene.

During my inspection, I identified unique characteristics of the scene that were documented in photographs taken nearer the time of the crash. I electronically documented the characteristics of the scene using a FARO Focus3D laser scanner. I analyzed these measurements and created a scaled diagram of the crash scene as shown in Figure 3. A graphic representation of the scene measurements is shown in Figure 4. I did not identify any environmental conditions at the scene that would have caused the crash, although other crashes have occurred in this area.

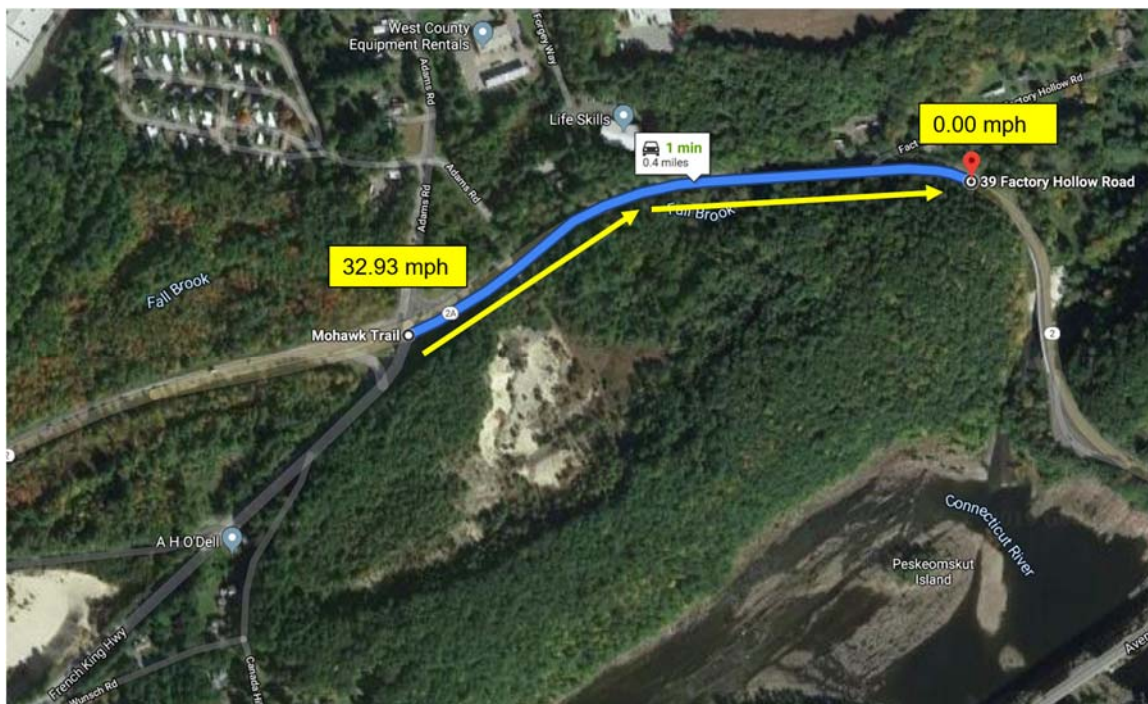
Figure 8. Satellite image with route report data.

of the crash; Mr. Bocoum likely did not stop at the Adams Road intersection traffic light. Figure 8 illustrates the approximate distance between the Adams Road intersection and the point of rest.

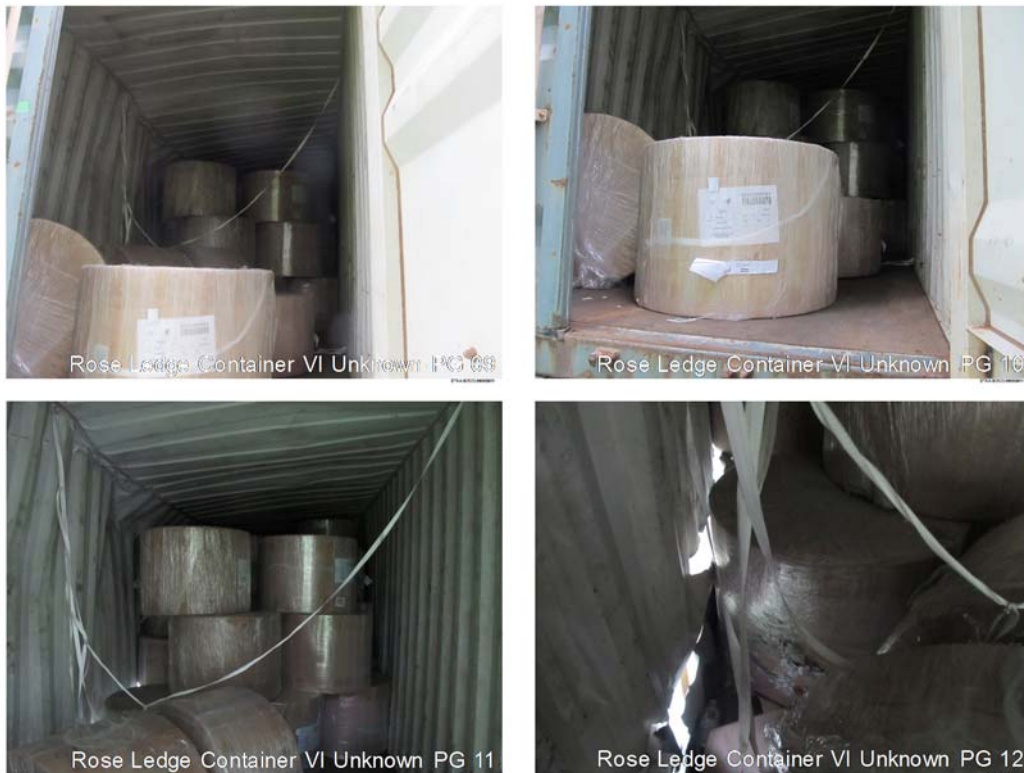
Figure 11. Contents of crash-involved trailer container.

The trailer was carrying a forty-foot shipping container. The limited photographs showed that the left side of the container on the trailer contacted the guardrail and guardrail posts during the crash sequence. The sheet metal on the left side of the container was diagonally torn or cut from midway on the forward end of the left side of the container to the bottom corner at the rear of the container. Abrasions appeared to be present on the left side of the container as well. The forward facing side of the container near its top edge was deformed with evidence of narrow object contact damage. The recovery team invoice description stated that “the front of the trailer had impacted a 30 [inch] tree.”¹⁸ Figure 10 shows four photographs of the subject container from different angles. Approximately eighty-two rolls of paper were in the container at the time of the crash that reportedly weighed 43,898 pounds.¹⁹ Photographs of the container’s contents are shown in Figure 11.

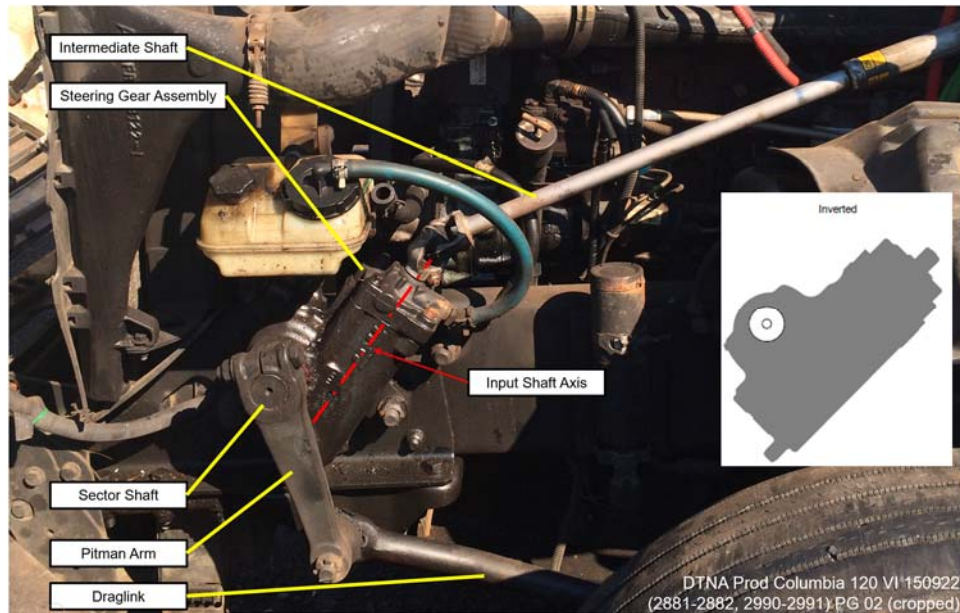
Figure 12. Steering gear assembly prior to removal (image cropped).

I inspected the crash-involved 2007 Freightliner Columbia steering gear assembly on September 12, 2019 in Newark, New Jersey. Prior to my inspection, the steering gear was removed from the subjected vehicle and disassembled. A photograph of the steering gear before it was removed from the vehicle is shown in Figure 12. The installed orientation of the steering gear assembly is an inverted mount, with the sector shaft located above the input shaft and worm screw axis. Only the steering gear was preserved and available for inspection; the pitman arm, draglink, and other essential steering system components were discarded and not available for inspection. At the time of my inspection, the steering gear assembly components were stored in a metal box that was locked with a security bolt. The steering gear assembly components were wrapped, bagged, and stored inside the box. I removed the components from the box, placed them on a table, and photographed them during my inspection.

Gear teeth cut into the rack piston mesh with gear teeth mounted on the sector shaft (Figure 13, No. 18); when the rack piston is translated, the sector shaft is rotated. Splines cut into the other end of sector shaft are used to mount the pitman arm, identified in Figure 12. Rotation of the pitman arm translates the draglink, Figure 12, which then turns the steering knuckle and moves the rest of the steering linkage. The mechanical movement of the rack piston is assisted by hydraulic fluid, thereby reducing the effort required for the driver to turn the steering wheel.

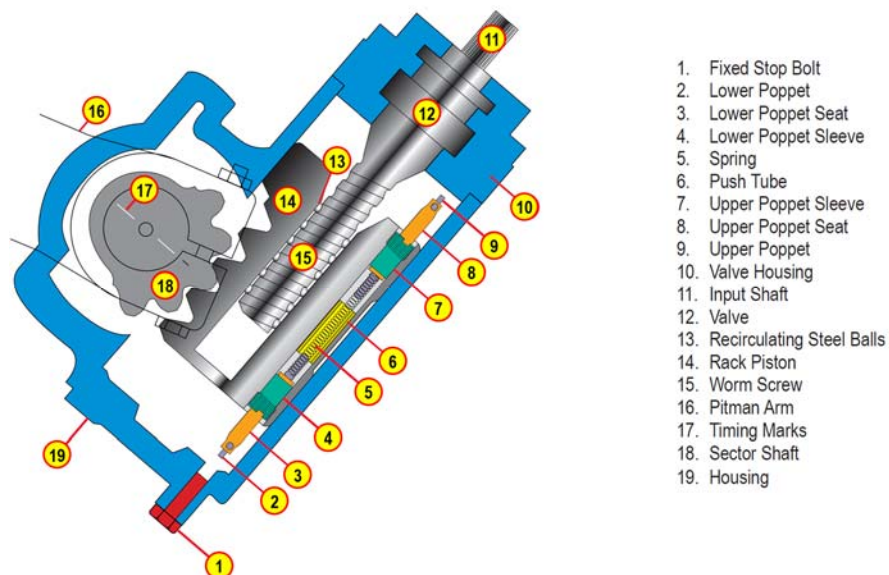
Figure 13. Steering Gear Assembly section diagram.²⁰

A steering gear section diagram of the subject steering gear is shown in Figure 13. The steering gear is designed to transmit steering inputs from the driver to the steering linkage that turns the road wheels. Driver steering inputs rotate the input shaft (Figure 13, No. 11) at the same angle and rate that the driver turns the steering wheel. The input shaft is connected to the worm screw (Figure 13, No. 15), which has a helix groove cut around its longitudinal axis that acts as a bearing race. Inside the rack piston (Figure 13, No. 14) is the companion helix groove of the worm screw, and recirculating balls (Figure 13, No. 13) that are located between the mating surfaces in the helix grooves of the worm screw and rack piston act as bearings. When the worm screw is rotated, the rack piston is translated axially along the worm screw's length.

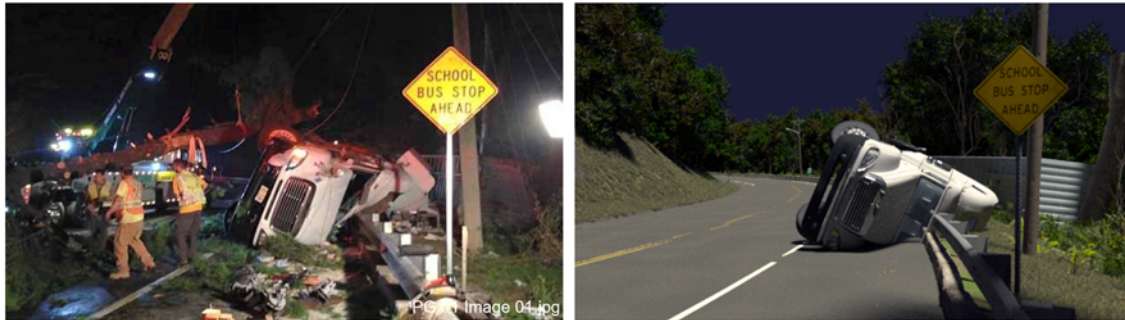
Figure 23. 2007 Freightliner Columbia 120 and double-axle cargo trailer point of rest.

The location of the left-front tire mark indicated in Figure 22 is consistent with the vehicle's point of rest. The chassis and frame structure of the 2007 Freightliner Columbia 120 came to rest on the asphalt roadway in the MA-2 westbound shoulder. The upper cab and body structure

of the Freightliner tractor contacted the stone curb and guardrail during the crash sequence and came to rest partially on the shoulder, stone curb, guardrail and roadside. The area of rest of the 2007 Freightliner Columbia 120 and double-axle cargo trailer was determined using three-dimensional graphical analysis, shown in Figure 23. At rest, the left-front tire was located on the westbound rumble strips and the front wheels were turned left, as visible in Figure 24. Rim flange abrasions, wheel discoloration and abrasions, and wheel stud abrasions on the left-front wheel of the 2007 Freightliner Columbia 120 are indicated in Figure 25. Abrasions on the tire sidewall were also observed. The physical evidence from the left-front wheel and tire assembly is consistent with abrasions from the asphalt roadway and rumble strip surface during the crash sequence indicated in Figure 22. The forces created between the asphalt roadway and the wheel and tire assembly imparted left-steer forces to the steering system and steering gear; left-steer movement imparted from the road wheels forced the pitman arm forward. This loading that was generated as the left side of the tractor was crashed into the pavement and the wheel and tire engaged the rumble strip is consistent with the physical evidence present in the steering gear components, and likely caused the damage present in the steering gear, including fracturing the worm screw. The steering gear was likely broken after the vehicle was overturned.

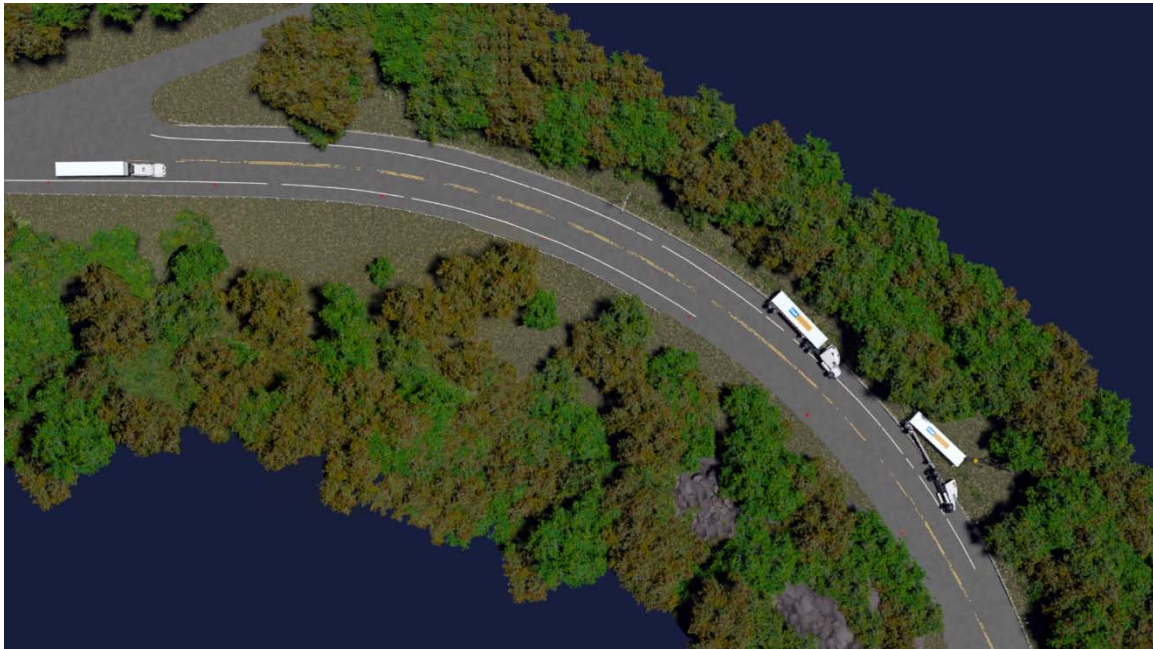
Figure 26. Top view of crash sequence.

At rest, the steered wheels were turned left even though Mr. Bocoum steered right through a right turn. The physical evidence indicates that Mr. Bocoum had steering throughout his right steer and the Freightliner tractor responded to his steering inputs by turning right. The damage to the left side of the trailer cargo container and a lack of similar damage to the tractor, along with the other physical evidence, indicates that the trailer was likely tracking outside of the tractor at the time of overturn. The approximate distance between the locations where the cargo trailer container initially contacted the guardrail and the area of rest was likely between 110 and 120 feet. Figure 26 shows a three-dimensional graphic view of the crash sequence.

Mr. Bocoum testified that he drove straight into the guardrail. If he drove straight into the guardrail as he testified, damage would have been present to the left-front bumper and the guardrail damage would have been more than 100 feet upstream of the crash location. The lack of damage to the left-front bumper and a matchup between the representative bumper height and the guardrail are shown in Figure 27; if Mr. Bocoum would have driven straight into the guardrail, the left-front bumper would have been damaged. The lack of damage to the left-front bumper indicates that the Freightliner tractor was steered away from the guardrail and did not make contact with the guardrail. The location where the cargo trailer container first contacted the guardrail demonstrates that Mr. Bocoum steered his tractor to the right and successfully negotiated a radius.
